**PRELIMINARY FACTUAL FINDINGS REPORT**  
**Derailed Union Pacific's Unit Crude Oil Train ONETU 02**  
**Transporting Bakken Crude Oil for U.S. Oil**  
**Mosier, Oregon**

**June 23, 2016**

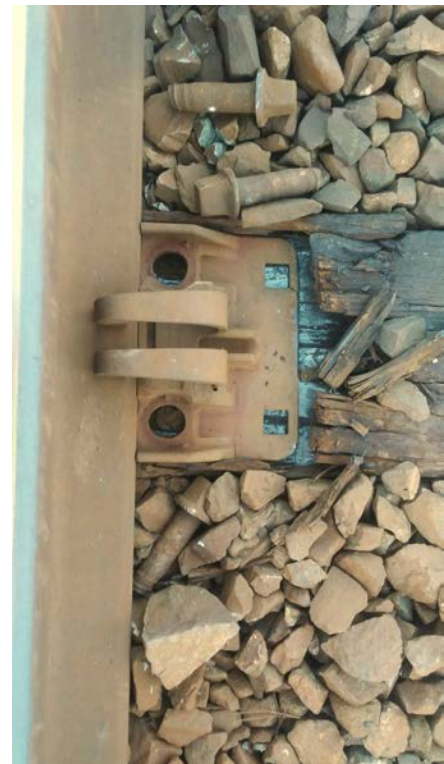
FRA's preliminary investigation determined the Union Pacific derailment was caused by broken lag bolts leading to wide track gauge.

FRA's investigation found that multiple lag bolts in this section of Union Pacific track were broken and sheared, leading to tie plates loosening from ties. The loosened tie plates allowed for the rails to be pushed outwards as trains moved across them, eventually resulting in an area of wide gauge, leading to the derailment.

Unless or until additional details come to light, FRA has made the preliminary determination that Union Pacific's failure to maintain its track and track equipment resulted in the derailment. Broken and sheared lag bolts, while difficult to detect by high-rail, are more detectable by walking inspection combined with indications of movement in the rail or track structure and/or uneven rail wear, and are critically important to resolve quickly.

**Image 1:**  
Image of broken bolts that allowed rails to go wide, causing wide gauge.
